## Ride-Rite™ Warranty Evaluation Guide

## Coverage

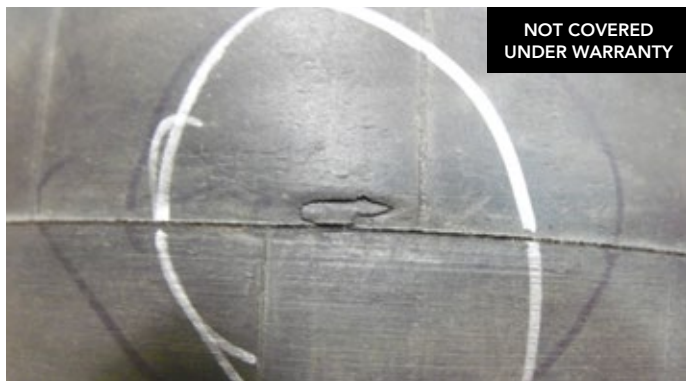
### Puncture

*Rubber bellows close-up*

- Irregular shaped cut in the bellows

- Debris punctured the bellows
- Mounted too close to a sharp object

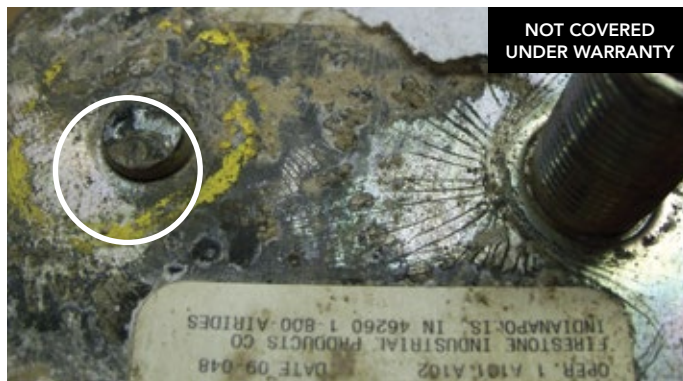
### Bent Alignment Pin

*Convolute shown*

- One side of alignment pin is pushed down toward the bead plate
- Marring or semicircular gouge in the top of the alignment pin
- Pin pushed in

- Alignment pin was not installed into the alignment pin hole in the bracket
- Attachment hardware not tightened

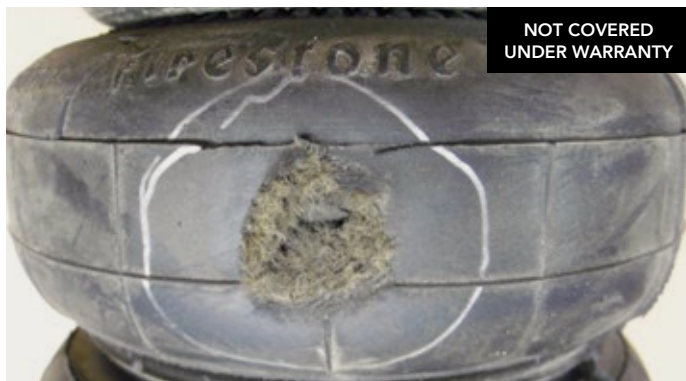
### Abrasion

*Convolute shown*

- Hole rubbed into side of bellows or in area that rolls over piston (sleeve style)

- Contacting a vehicle or other suspension component
- Inadequate air pressure
- Road debris
- Oversized tire contact
- Snow chain contact
- Inadequate tire to frame clearance

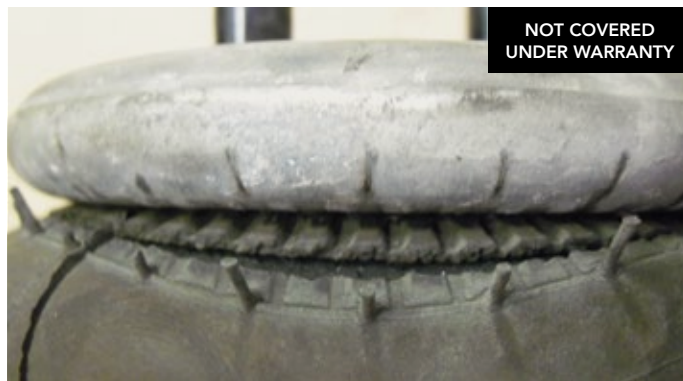
### Circumferential Cuts

*Convolute shown*

- Bellows cut or separated around the perimeter of bead plate or piston

- Too much air pressure, over extended for long periods of time
- Bottoming out
- Air spring overextended
- Normal wear and tear over years of usage

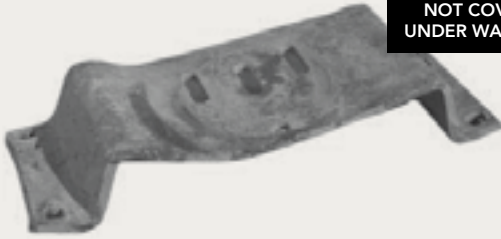
## Bent or Broken Brackets & Bolts

- Distorted shape
- Possible cracking or "tearing"

- Not enough air pressure in the system for the load
- Overloading the vehicle/air springs
- Bottoming out

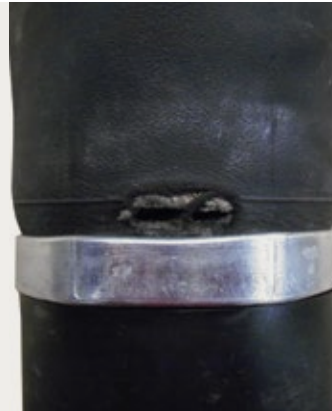
## Bottoming Out

- Bent brackets or beadplates
- Broken girdle hoop (convoluted parts), caps or pistons (sleeve parts)
- Cuts near the bead plates, caps, or pistons
- Leaking around blind nuts

- Installation height is too low, resulting in air spring too short
- Not maintaining the minimum air pressure
- Not enough air pressure for the load
- Overloading the vehicle/air springs

*Tapered sleeve shown*

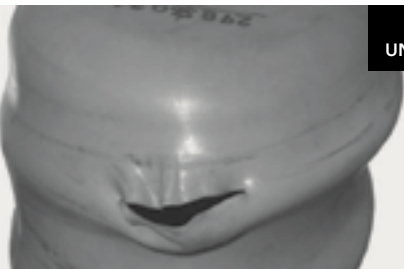
## High Temperature / Over Inflation

*Coil-Rite™ shown*

- Tear in the side of the part, material seems thin or "stretched"

- Exposed to high temperature for long periods of time (too close to exhaust)
- Over inflation (see manual for max operating pressure)

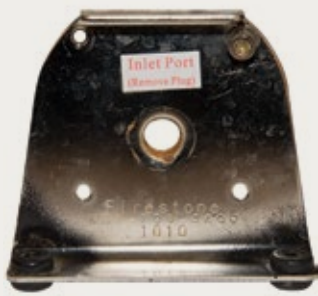
### Inlet Plate

- Rust around threads of inlet port
- Compressor will not pump air
- Compressor runs at high current (blows fuses)

- Compressor was submerged
- Air filter assembly was not installed properly

- Replace compressor
- Snorkel air filter to a dry, dust free location (max 6ft)
